## WOOD DESTROYING PESTS AND ORGANISMS INSPECTION REPORT

| Building Address:<br><b>1316 N. Wilson Drive, Pasadena, CA 91103</b> | | Date of Inspection<br><b>04/02/2024</b> | Number of Pages<br><b>8</b> |

Address 1316 N. Wilson Drive, Pasadena, CA 91103

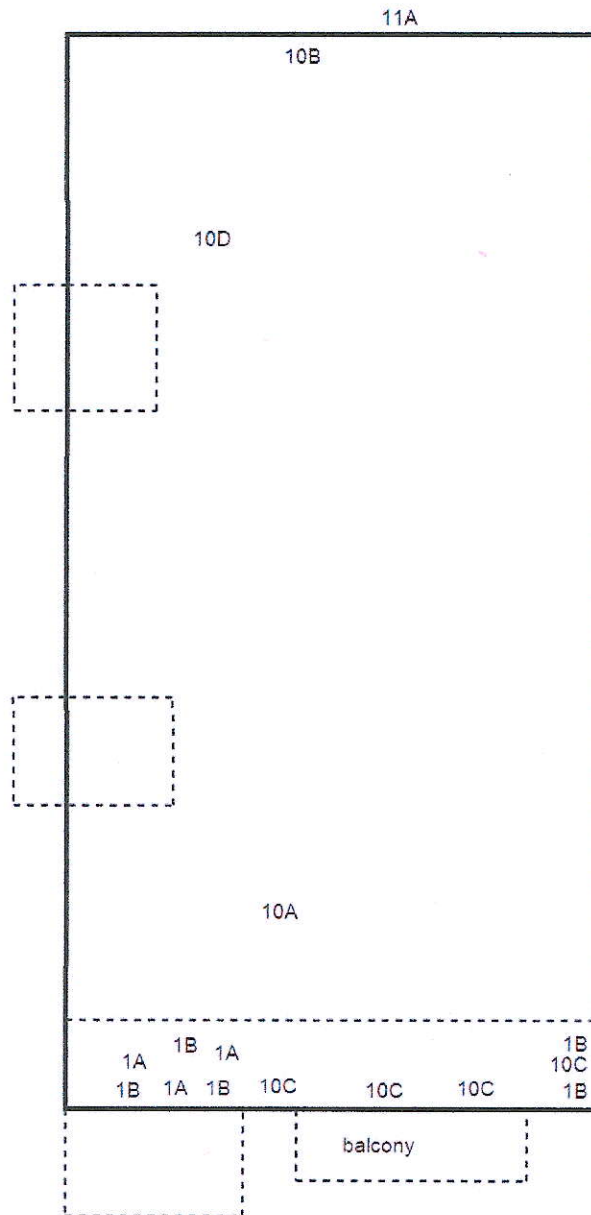
**This Diagram is not to scale**

- 1A (Section II)  
FINDINGS: Earth-wood contacts visible at time of inspection at the storage closet left of first garage as indicated on the diagram.  
RECOMMENDATION: Eliminate earth-wood contacts as found necessary.
- 1B (Section I)  
FINDINGS: Evidence of subterranean termites noted at storage closet left og first garage.  
RECOMMENDATION: Chemically treat this area for control of subterranean termites. Local treatment is not intended to be an entire structure treatment method. If infestations of wood-destroying pests extend beyond the area(s) of local treatment, they may not be exterminated.

10B (Section I)  
FINDINGS: Evidence of dry-wood termite infestations at the unit 10 bathroom window as indicated on the diagram.  
RECOMMENDATION: Vacate the premises and seal the structure for fumigation with Vikane (Sulfuryl Flouride) gas with a Chloropicrin warning agent or Zythor (Sulfuryl Flouride) with a Chloropicrin warning agent, for a kill of the drywood termite infestation(s), then this Company to remove or mask the evidence of the drywood termites for the benefit of future inspections. Fumigation may be cancelled due to inclement weather such as, strong winds or rain. King Termite Control, Inc. nor the fumigation company assumes any responsibility or liability for plant, antenna or roof damage. Fumigation notice forms must be signed prior to fumigation and neighbor's authorization, if applicable. See fumigation notice for terms and liabilities.  
SECONDARY RECOMMENDATION: SECONDARY RECOMMENDATION IN LIEU OF FUMIGATION: Chemically treat visible and accessible infestations only. Remove or cover accessible evidence of infestation. This is a sub-standard recommendation. Limited guarantee due to concealed areas not being treated. Secondary work requested by \_\_\_\_\_.

10C (Section I)  
FINDINGS: Evidence of dry-wood termite infestations at the storage closet in sub area left of first garage as indicated on the diagram.  
RECOMMENDATION: Vacate the premises and seal the structure for fumigation with Vikane (Sulfuryl Flouride) gas with a Chloropicrin warning agent or Zythor (Sulfuryl Flouride) with a Chloropicrin warning agent, for a kill of the drywood termite infestation(s), then this Company to remove or mask the evidence of the drywood termites for the benefit of future inspections. Fumigation may be cancelled due to inclement weather such as, strong winds or rain. King Termite Control, Inc. nor the fumigation company assumes any responsibility or liability for plant, antenna or roof damage. Fumigation notice forms must be signed prior to fumigation and neighbor's authorization, if applicable. See fumigation notice for terms and liabilities.  
SECONDARY RECOMMENDATION: SECONDARY RECOMMENDATION IN LIEU OF FUMIGATION: Chemically treat visible and accessible infestations only. Remove or cover accessible evidence of infestation. This is a sub-standard recommendation. Limited guarantee due to concealed areas not being treated. Secondary work requested by \_\_\_\_\_.

FINDINGS: Dry-rot wood members found at time of inspection at the laundry door frame as indicated on the diagram.

RECOMMENDATION: Repair and/or replace damaged wood as necessary. Painting included. If additional damage is uncovered during repairs, further inspection may be recommended and a supplemental report will be issued indicating any infection, or additional repairs.
